REPORT OF INVESTIGATIONS/1989

Effects of Structural Faults on Ground Control in Selected Coal Mines in Southwestern Virginia

By Gregory M. Molinda and David K. Ingram

BUREAU OF MINES

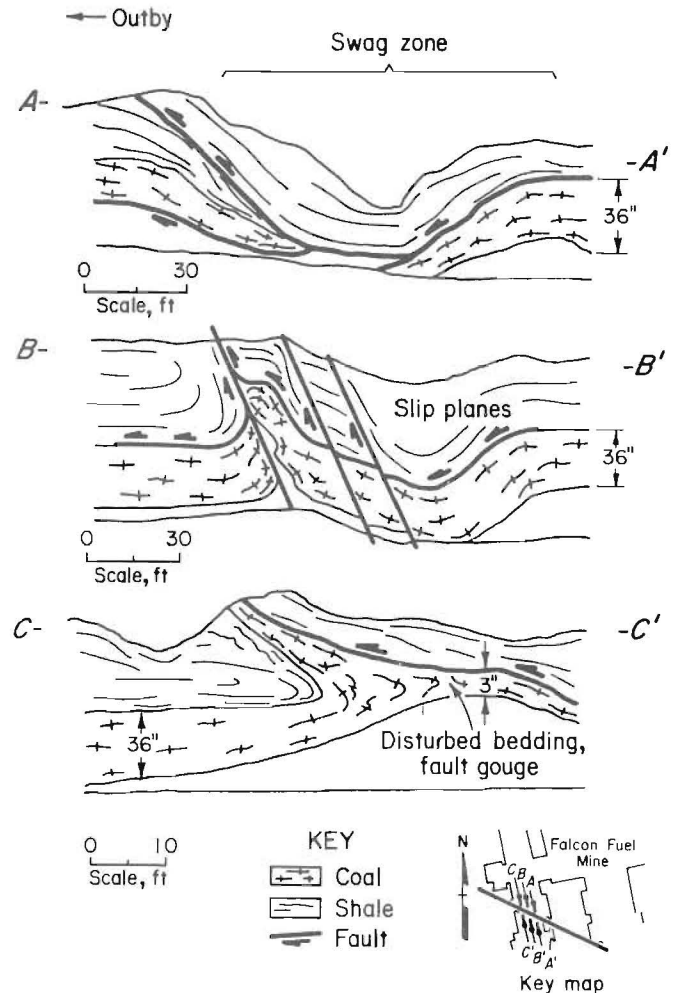
At cross section B-B' (only 50 ft away), the nature of the disturbance is different (fig. 6). Here, the compressive forces have dragged the coalbed into the roof and partially severed it. A series of three main faults have isolated two fault blocks, which have been uplifted as horsts. The coalbed and adjacent strata have been severely disturbed

Figure 6.—Series of cross sections of Pistol Gap Fault exposed in Falcon Fuel Mine.

Figure 6 (cross section B-B') also shows that the fault zone is accompanied by a swag zone up to about 75 ft wide where the coalbed is downbuckled approximately 8 ft. This feature is characteristic of compressional stress fields in both these cross sections and may serve to warn miners that they are approaching a fault. Figure 11 shows an interpretation of events in the formation of bedding plane faults at the site of the existing Pistol Gap Fault. Section A is the coalbed with the existing strike-slip fault; sections B-D are subject to increasing lateral compression until complete failure in section E. Section B shows the development of the swag, which precedes bedding plane failure in section C. In sections C and D, the severed coalbed is telescoping past itself as the thrust fault shears upward into the roof. The strike-slip fault plane is also deformed. Continued compression also warps the coalbed in the vicinity of the vertical failure.

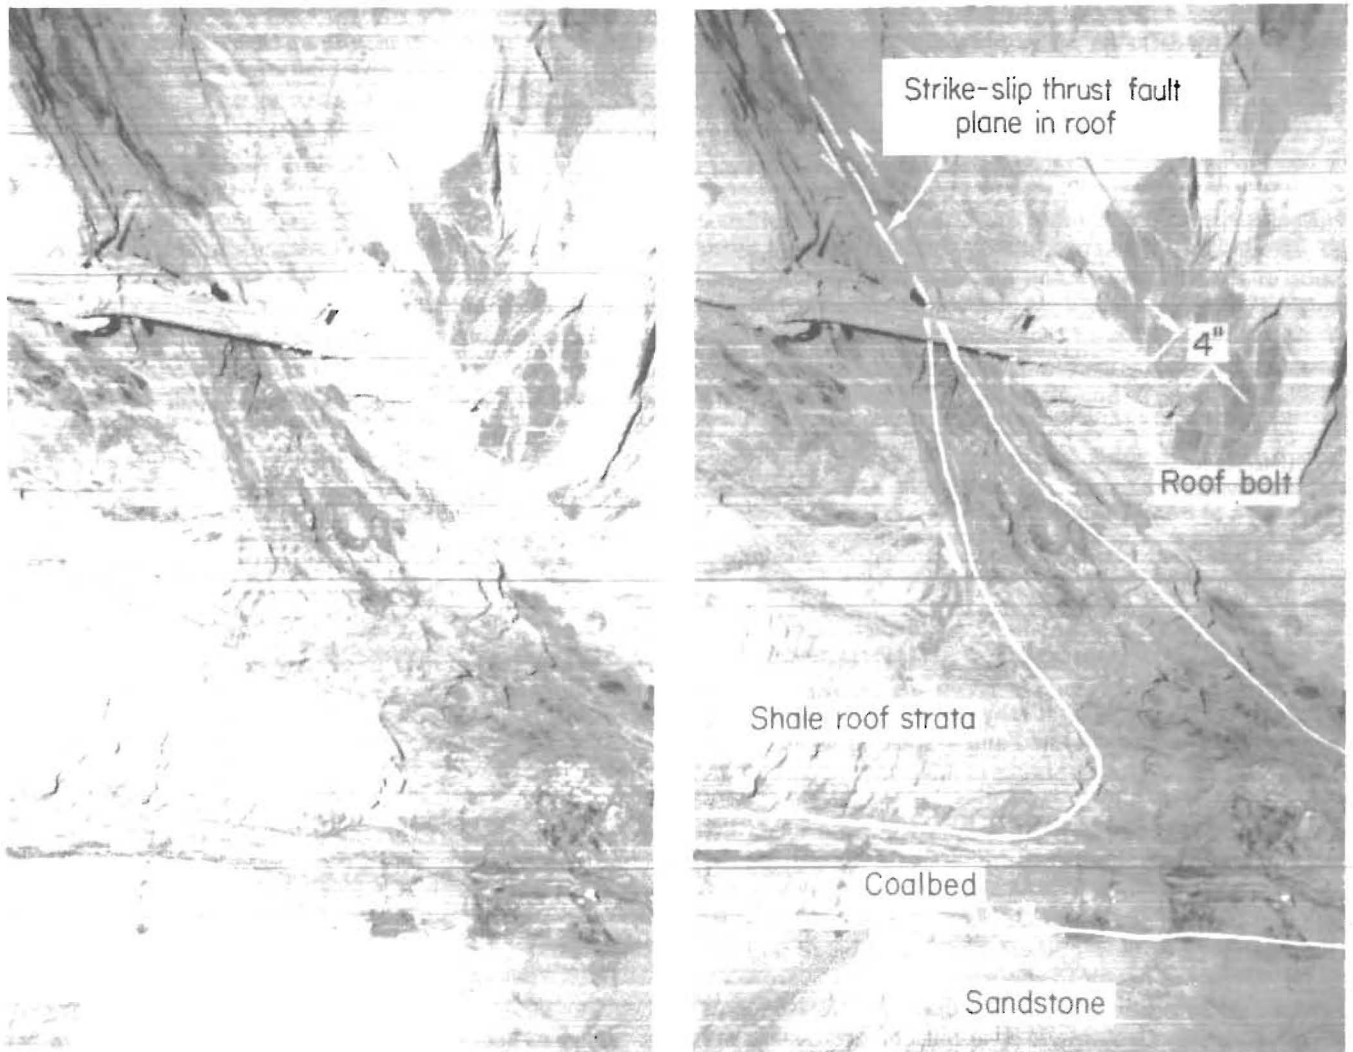
between the fault planes (coal fragmentation, fault gouge, and cleat rotation). The mine operator notes that roof bolts have been sheared in the vicinity of the fault, indicating active bedding plane movement since bolt installation. The movement, which has caused bolts to be sheared, appears to be mining induced and not the result of active tectonic compression. The entire mine is above drainage and therefore not subject to farfield horizontal stresses. In both cross sections A-A' and B-B', the Jawbone Coalbed has been overturned because of compression. Also, at all three places where the fault is exposed, horizontal (strike-slip) movement is indicated by slickensides. Roof conditions in the three accessible entries were poor for nearly 200 ft, with falls averaging 8 ft high and extending up to 20 ft high (fig. 10). Supplementary roof support included heavy crossbar sets, posts, I-beams, and resin bolts longer than 8 ft.

Figure 7.—Severe strata deformation and unstable roof caused by Pistol Gap Fault. Coalbed overturned and dragged upward.

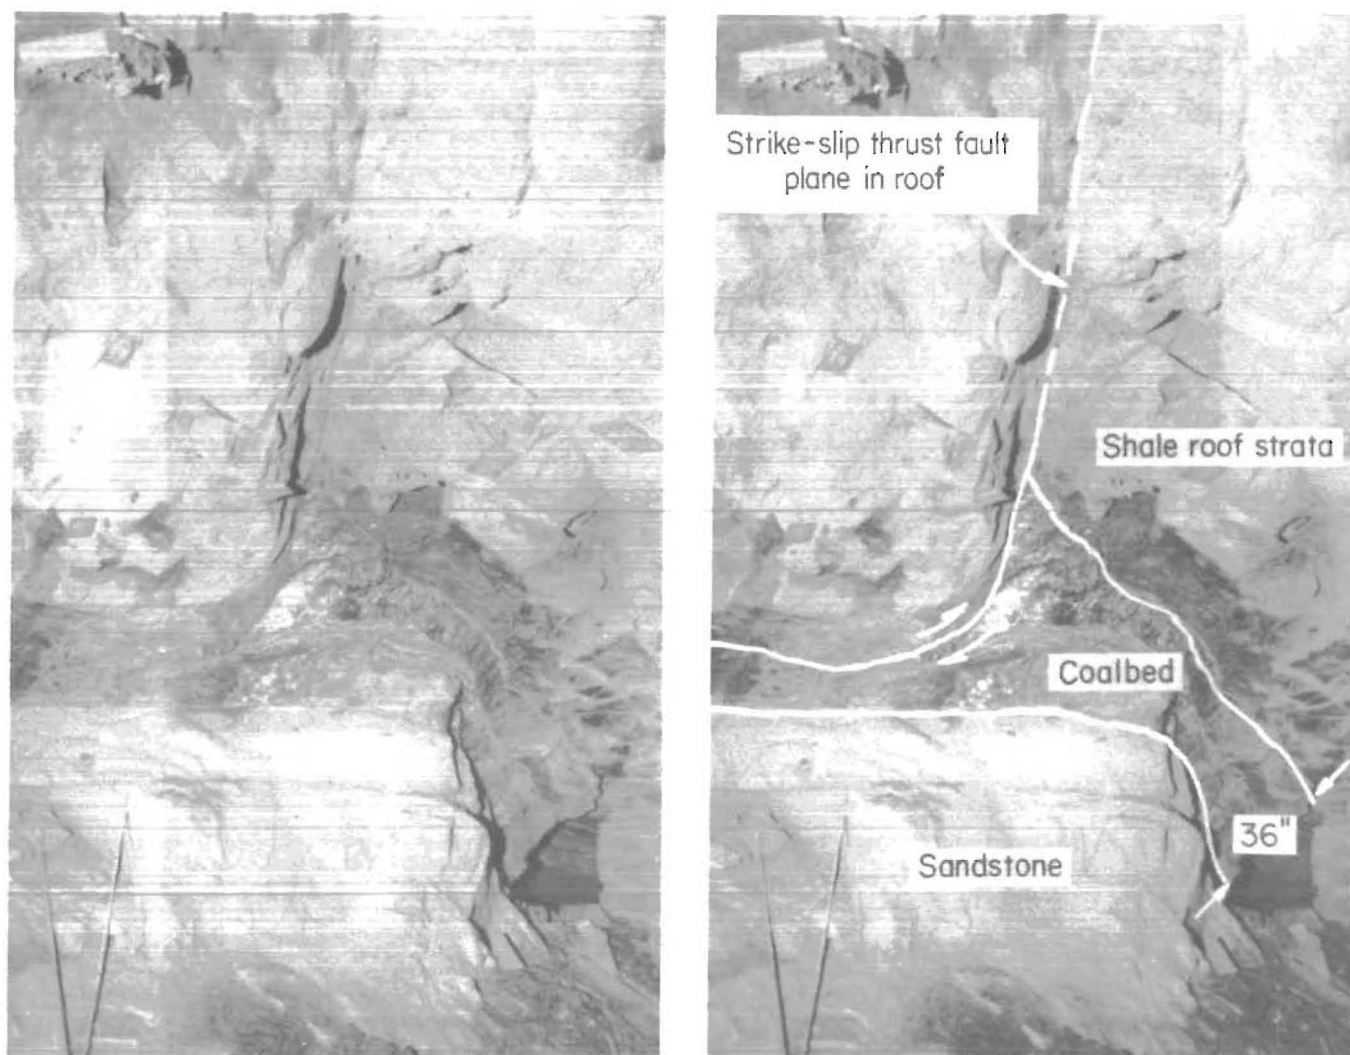
Figure 8.-Coalbed paralleled by bedding plane fault, which then shears into roof, causing roof fall.

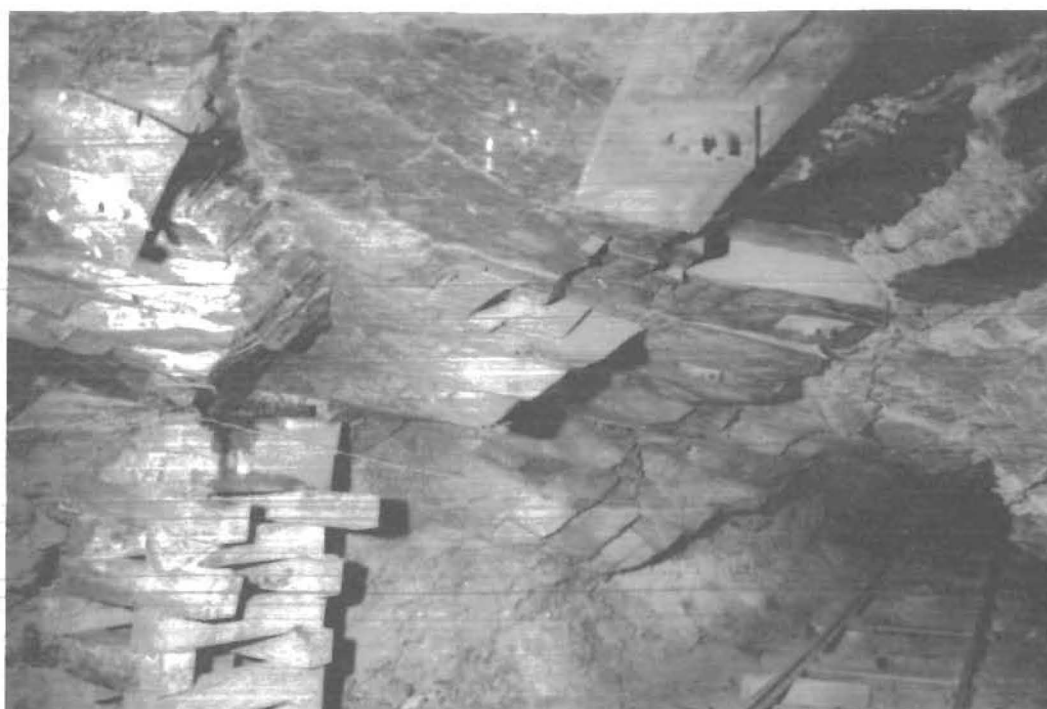
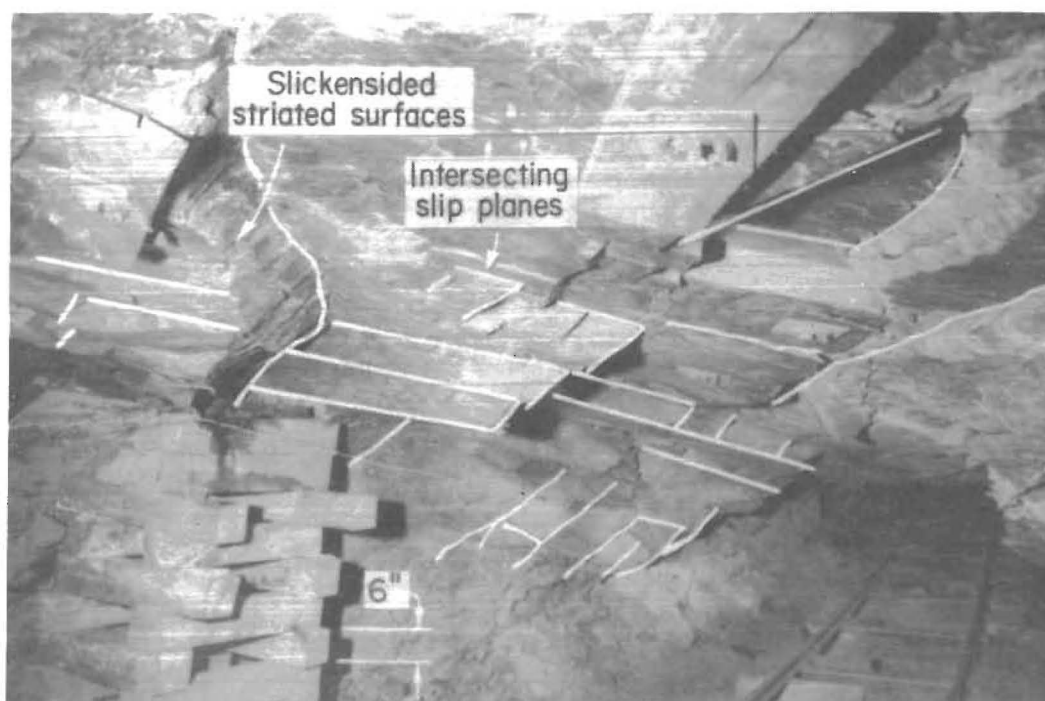
Figure 9.—Bedding plane fault exposed at coal-roof interface. Vertical fractures isolate hazardous roof blocks.

In a number of cases where the fault was mined through, the intersection of two or more opposite-dipping bedding plane faults caused the roof to drop out in blocks. These blocks should be supported by angle bolts, roof trusses, or straps to prevent arching falls. In all cases, the coalbed and surrounding draw slate and roof shales are severely disturbed. This disturbance is caused by compression and crushing of rock. Fault gouge is found along bedding plane faults and also vertically where the coalbed is dragged into the roof. This crushed rock has very low strength and should be avoided as a sole anchor for roof bolts.

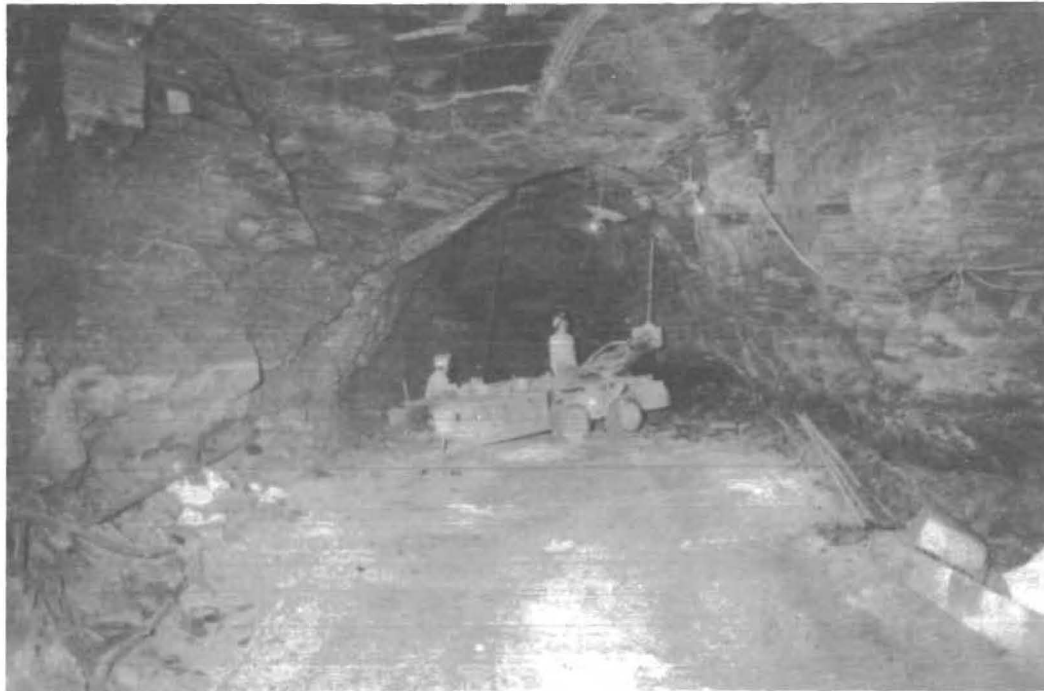
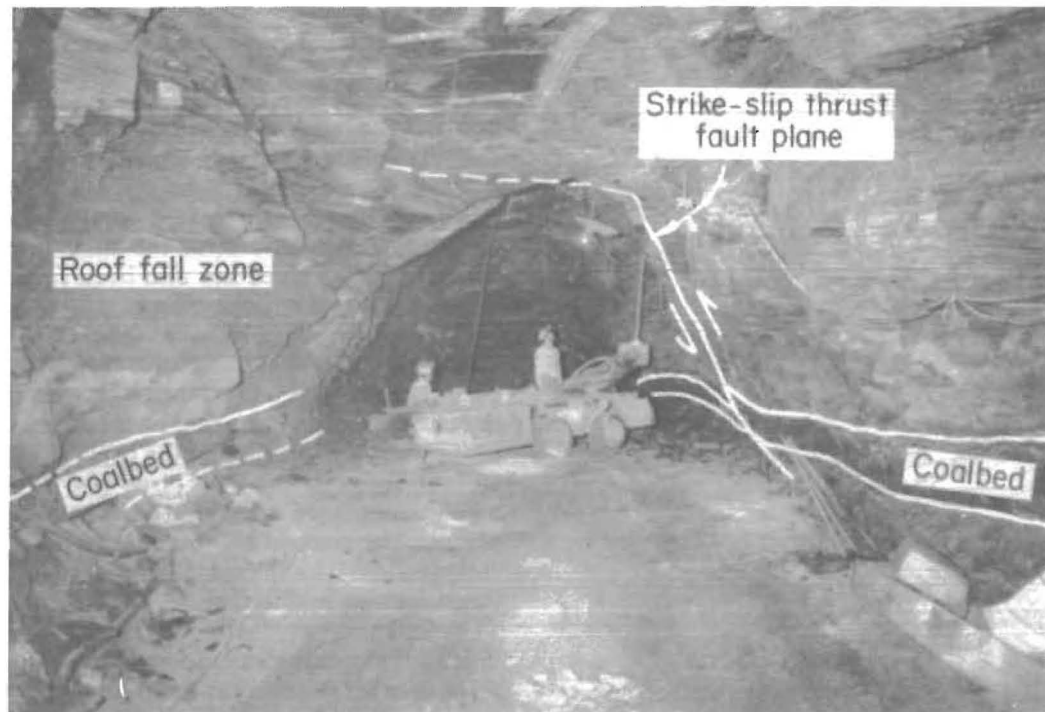
Figure 10.-Rehabilitation of high-roof fall in entry crossing Pistol Gap Fault zone.

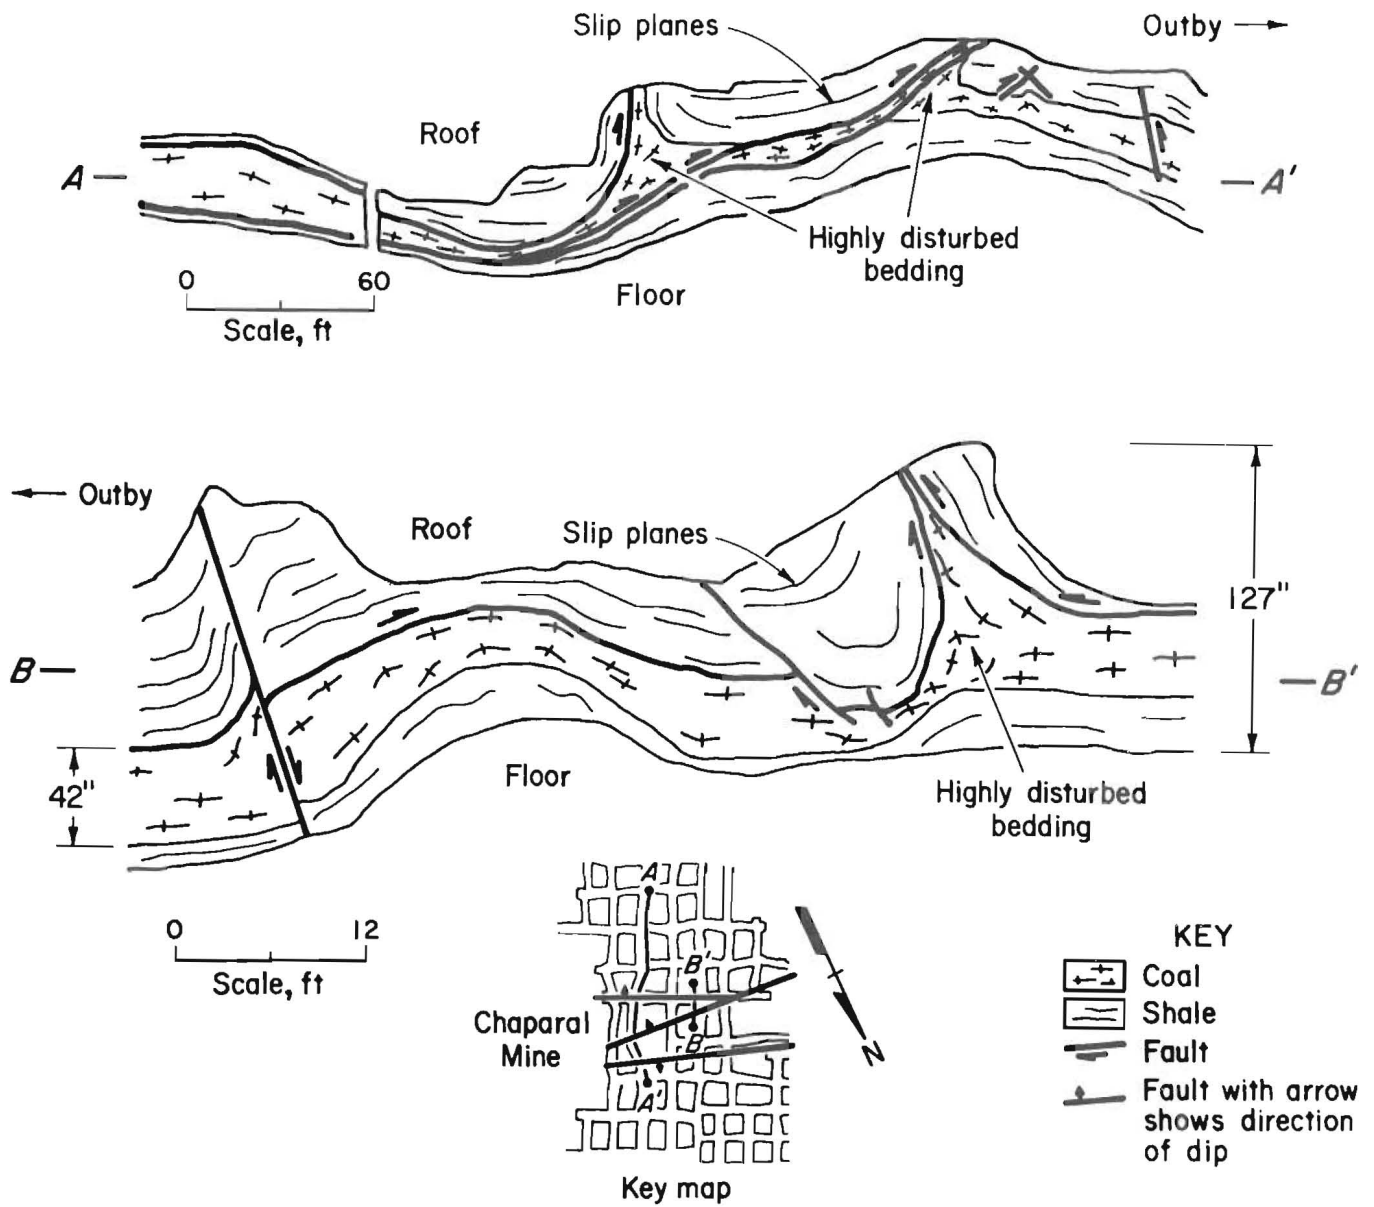
The Chaparal Mine is another contract mine to United Co. This drift mine works the Jawbone Coalbed and has intersected the Pistol Gap Fault while driving a south-western development (fig. 4). Figure 12 shows two cross sections through the fault zone. Cross section A-A' shows a large swag zone (approximately 230 ft wide) inby the fault zone. The Jawbone Coalbed has been buckled down 4 to 5 ft before returning to normal elevation outby the faults. As in the Falcon Fuel Mine, compression that oriented northeast-southwest caused a swag to the southwest of the fault zone. The coalbed failure is evident because a bedding plane fault exists at the coal-roof interface and between the roof and floor (fig. 13). This bedding plane fault then ramps up into the roof, causing a roof fall. The coalbed has been smeared out to only several inches thick. Also, there is a well-defined fault gouge zone that marks several of the fault planes within the coalbed. The coalbed has also been rippled, as seen on the outby side of cross section A-A' (fig. 12). This local "thin skinned" rippling is a common compressional feature.

Cross section B-B' shows the same failure reaction to compression. The outby block has been buckled up and the inby block has been split by the outby block (fig. 12), causing upward thrusting of the coalbed into the roof and an overturning of the fault plane (fig. 14). The coalbed and the roof strata are highly disturbed between the fault planes. The coalbed also thickens to over 93 in owing to compression. This thickening seems to be characteristic of thrust faulting in this area.

Figure 12.—Cross sections of Pistol Gap Fault exposure in Chaparal Mine.

To minimize production loss and hazardous roof conditions, the operators were forced to narrow the development in order to cross the fault. In addition, fewer crosscuts were turned, which made pillars over twice as long as normal. Again, the narrow development causes restrictions to ventilation. Roof conditions were very poor in the 100- to 150-ft-wide fault zone. Most of the entries crossing the fault were inaccessible because of dangerous roof. Several falls were over 15 ft high and had to be supported by elaborate terraced cribbing (fig. 15). Within the fault zone, numerous intersecting fault planes broke the roof into blocks and made rock bolting ineffective.

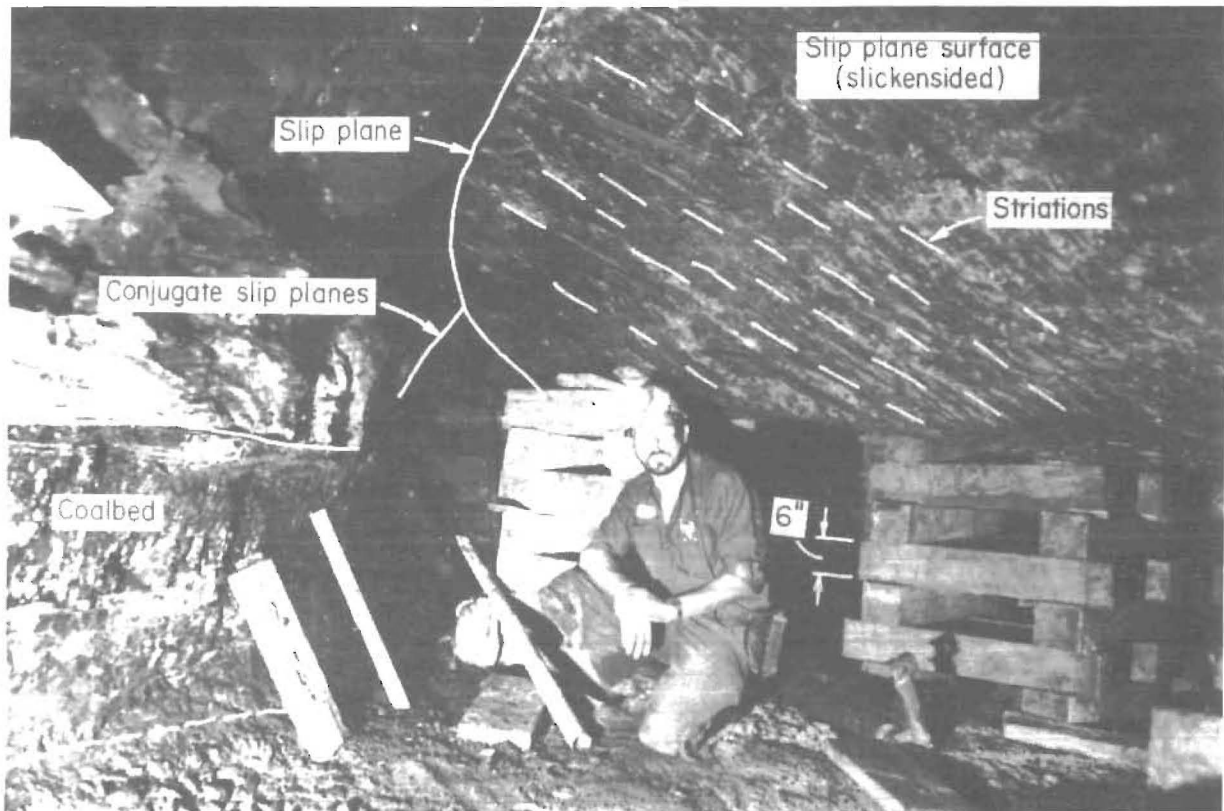
Figure 13.—Bedding plane fault rising into roof, showing roof fall caused by section of roof spalling away from fault plane.

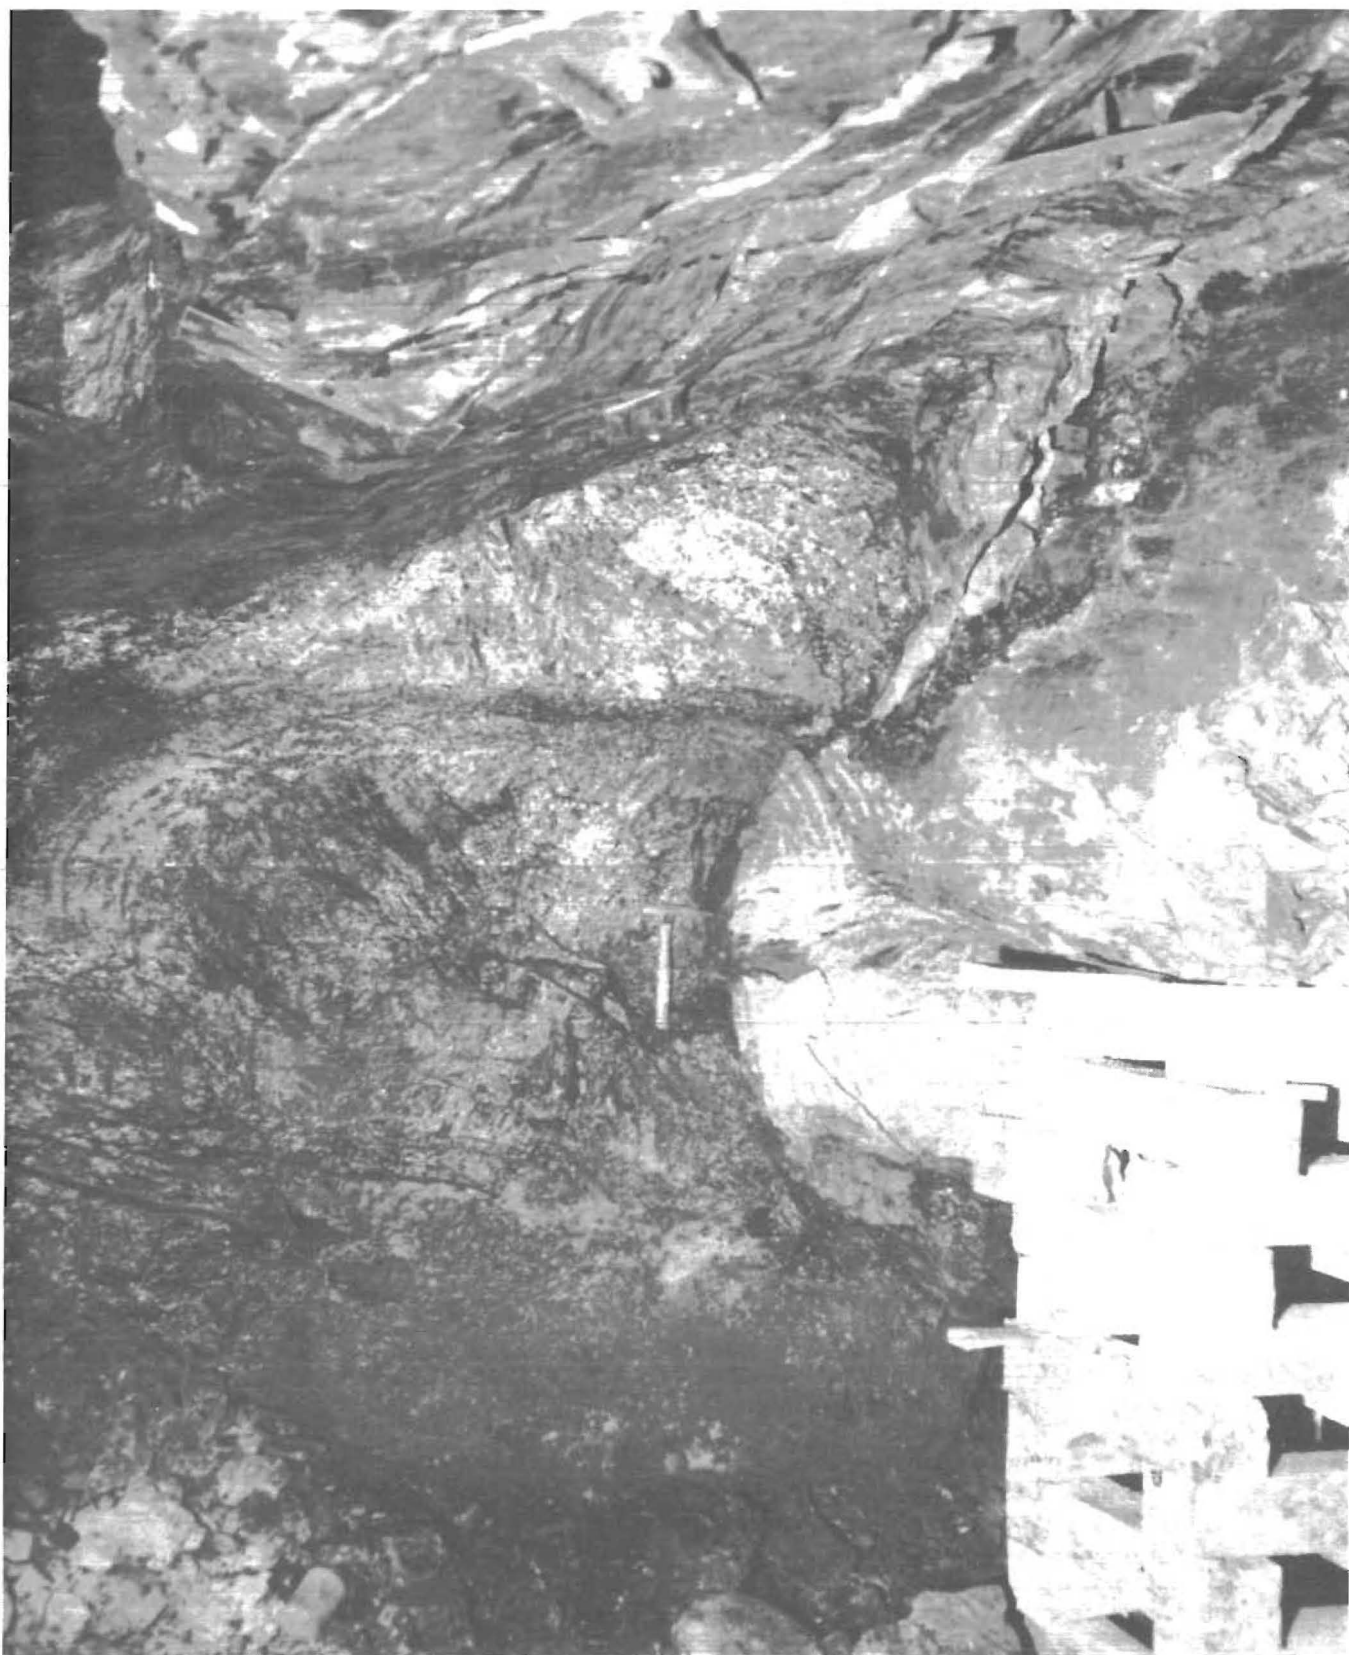
Figure 14.—Jawbone Coalbed split by compression along Pistol Gap Fault, with top half riding up into roof and bottom half pushed into floor.

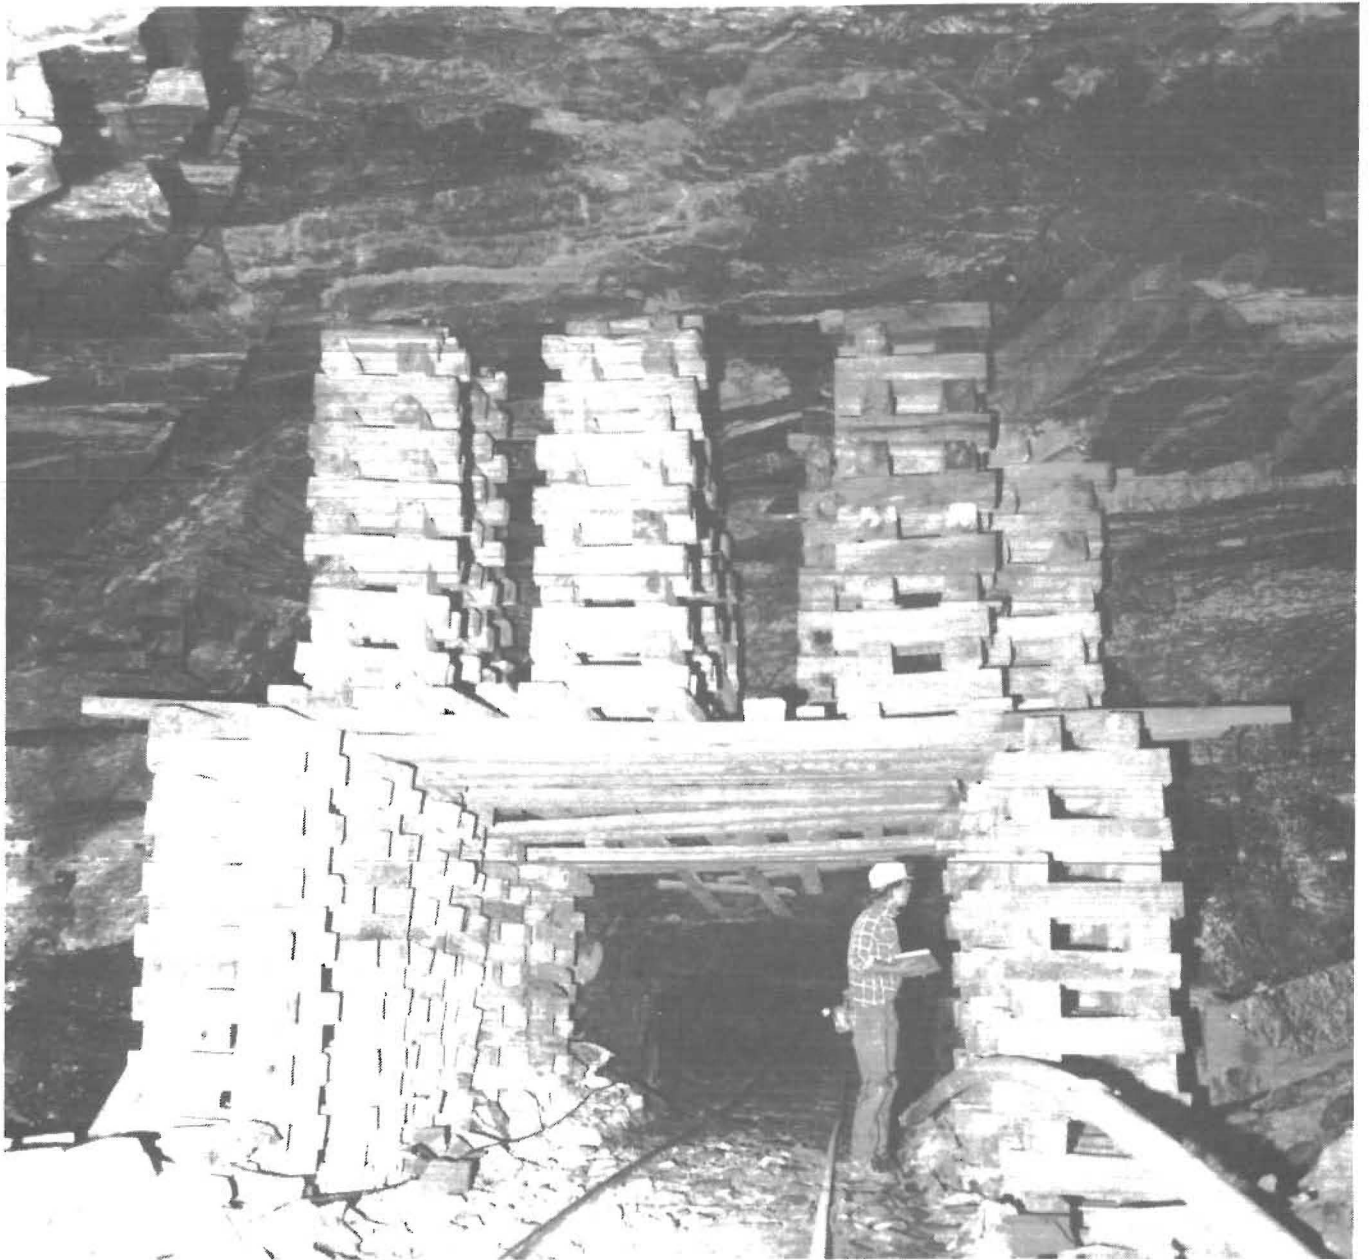
Figure 15.-Two-tiered cribbing platform, built to support high-roof fall in Chaparal Mine.

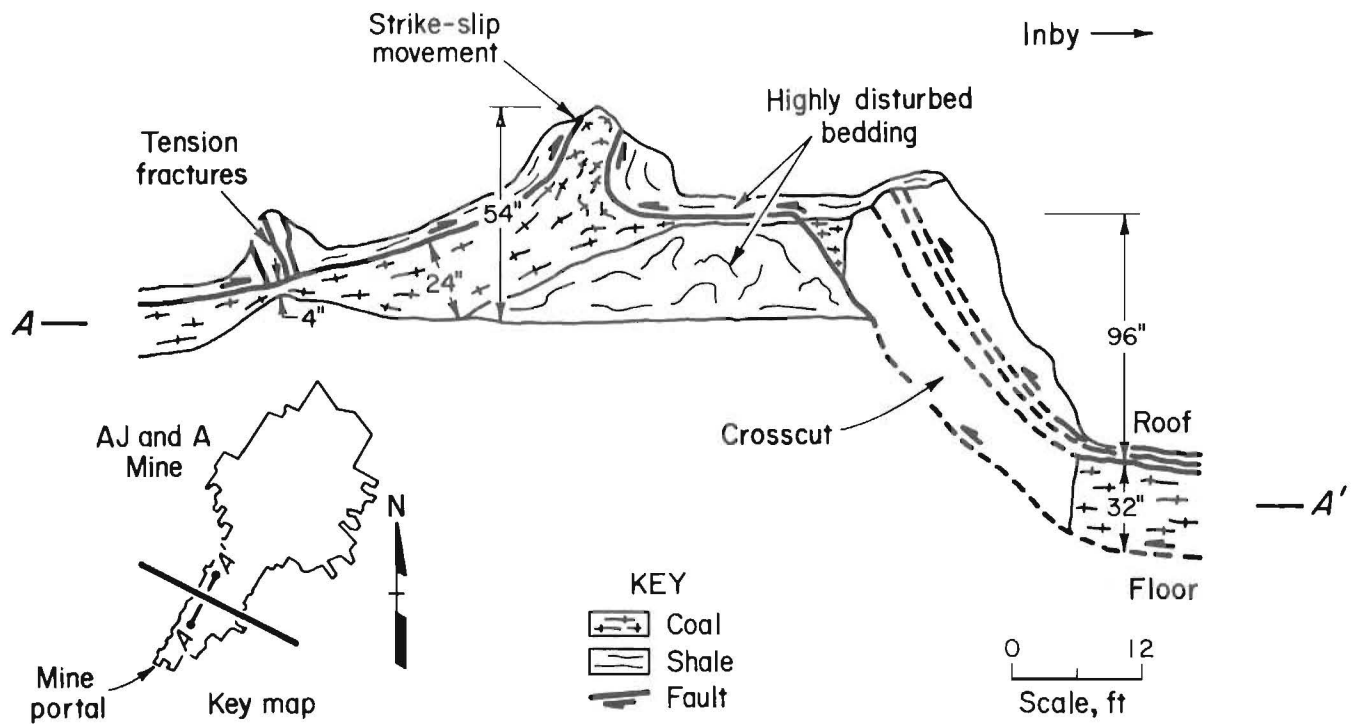
Figure 17.—Cross section of Pistol Gap Fault at AJ and A Mine.

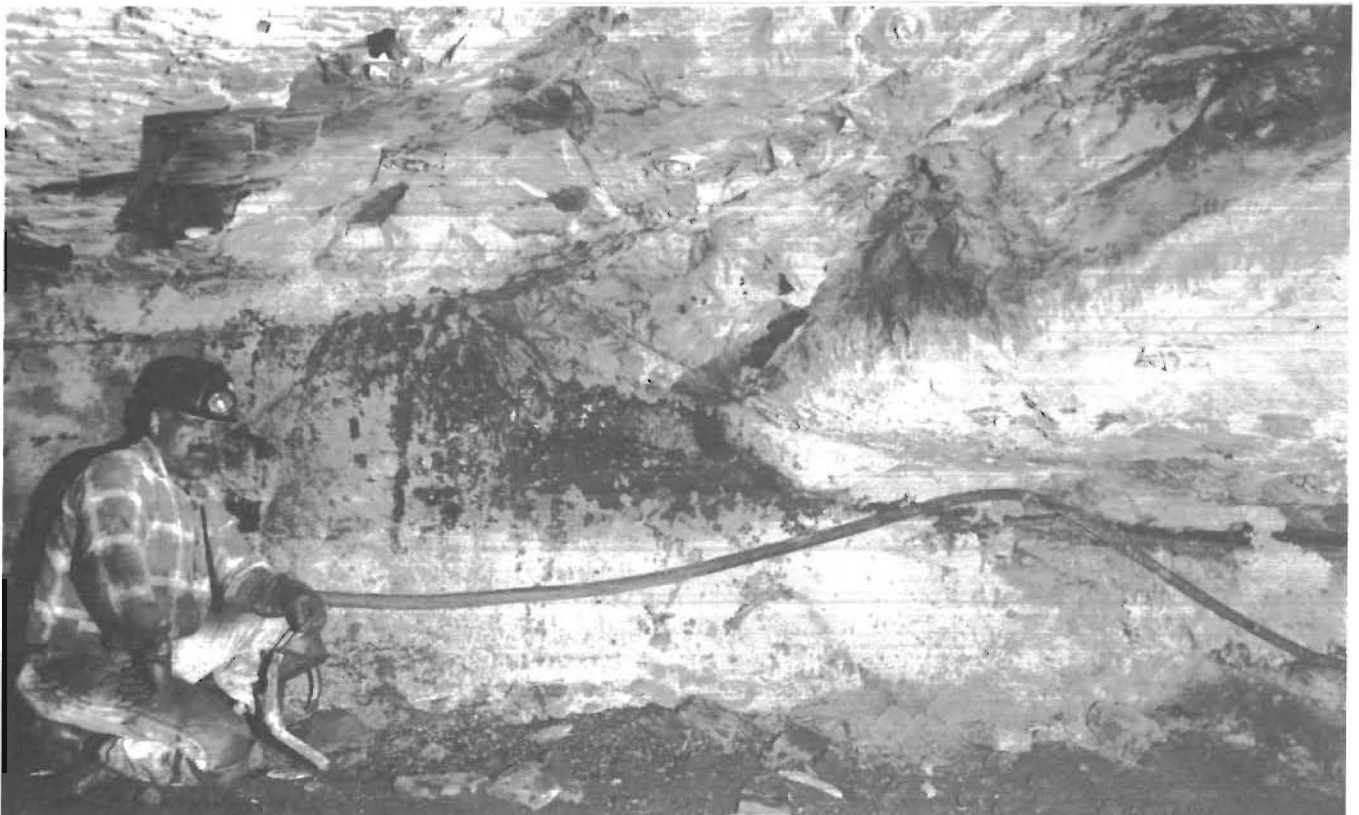
Figure 18.—Pistol Gap Fault exposed in rib at AJ and A Mine.

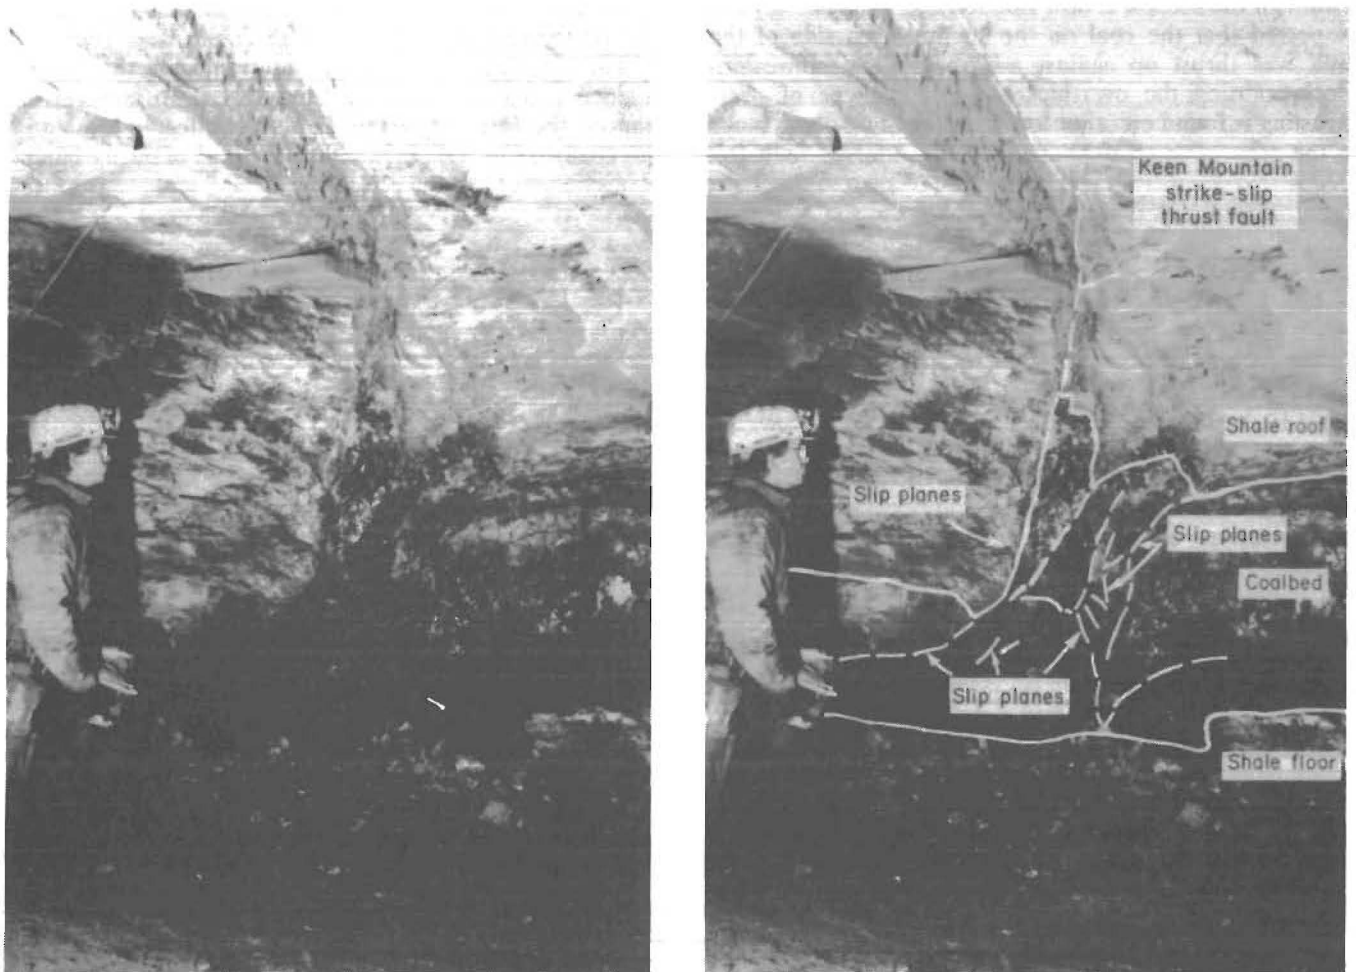
undetermined distance until it abruptly enters the roof (60°), causing a 3-ft-high fall of roof. Figure 21 shows the bedding plane fault and the associated roof disturbance. Numerous horizontal slickensides and polished surfaces indicate extensive slippage between the coal and immediate roof shales. Compression in a northeastern-southwestern direction has caused the coalbed to be dragged up into the roof and locally thickened (over 72 in). Slippage within the coalbed is apparent, and bedding is highly disturbed. The adjacent roof shales are also highly distorted. Failure occurred along the roof-coal interface and also along the bedding planes within the coalbed (fig. 21).

Figure 21.—Exposure of Keen Mountain Fault zone in Jawbone Coalbed, showing disturbed coalbed with fault plane entering roof.

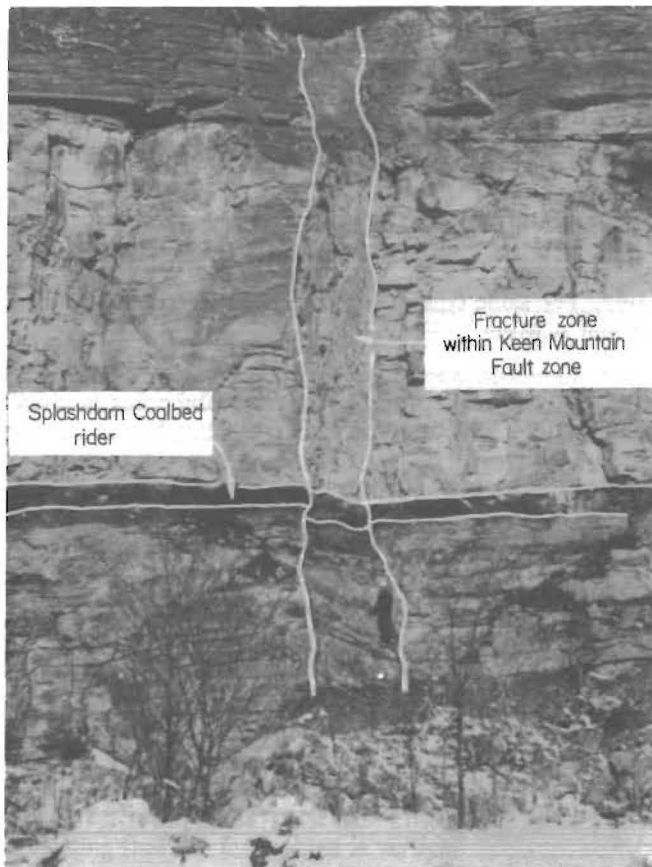
Figure 24.—Keen Mountain Fault zone exposed in highwall of surface mines.

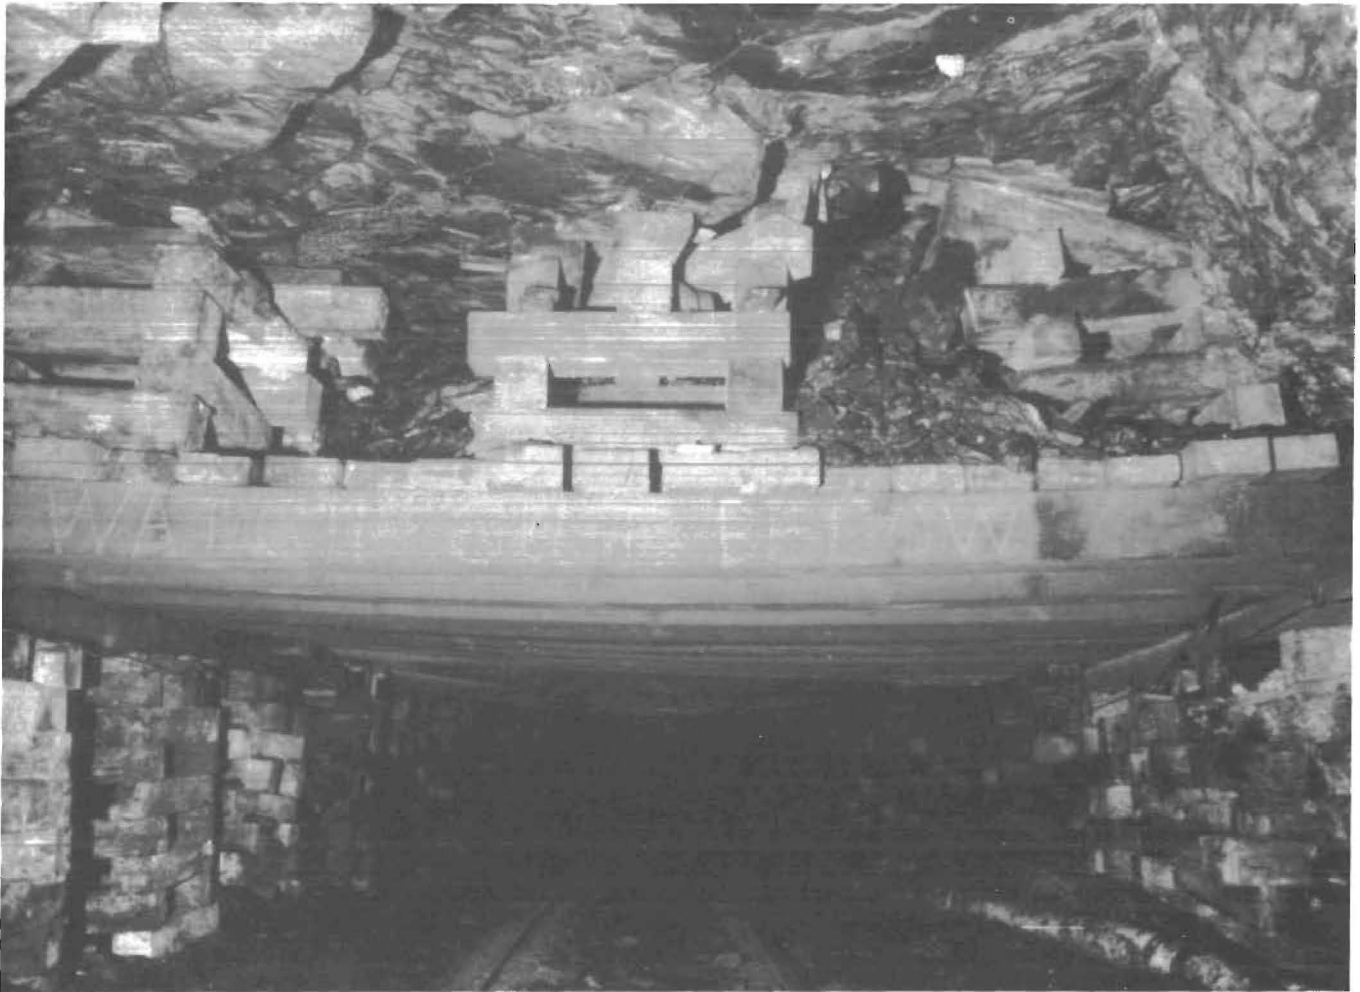
Figure 27.—Permanent structure used to support roof through fault zone.

By using appropriate roof support when mining through a fault zone, mine operators can avoid hazards, costly clean up, and rebolting of roof failures. It was found that the most common supplemental supports are cribs used in conjunction with cross collars (4- by 12-in wood planks) (fig. 27). Point anchor resin or other resin-assisted bolts can be used in fragmented roof. Also, angle bolting or truss sets can be used to hold roof members together. Crossbars, steel mats, or wire mesh used in conjunction with bolts decrease spalling of immediate mine roof. Large slip or fault planes disrupt the lateral continuity of the immediate and sometimes main roof. These conditions are most severe when these structures are orientated parallel or subparallel to the direction of mining. With this type of orientation, the mine roof may be segmented into cantilever beams. The cantilever effect can be reduced by bolting and strapping together the roof on each side of the slip or fault plane to form an integral built-in beam (fig. 28). Angle and orientation (strike and dip) of the slip or fault plane should be considered when determining the length and angle of installation of the roof bolt.

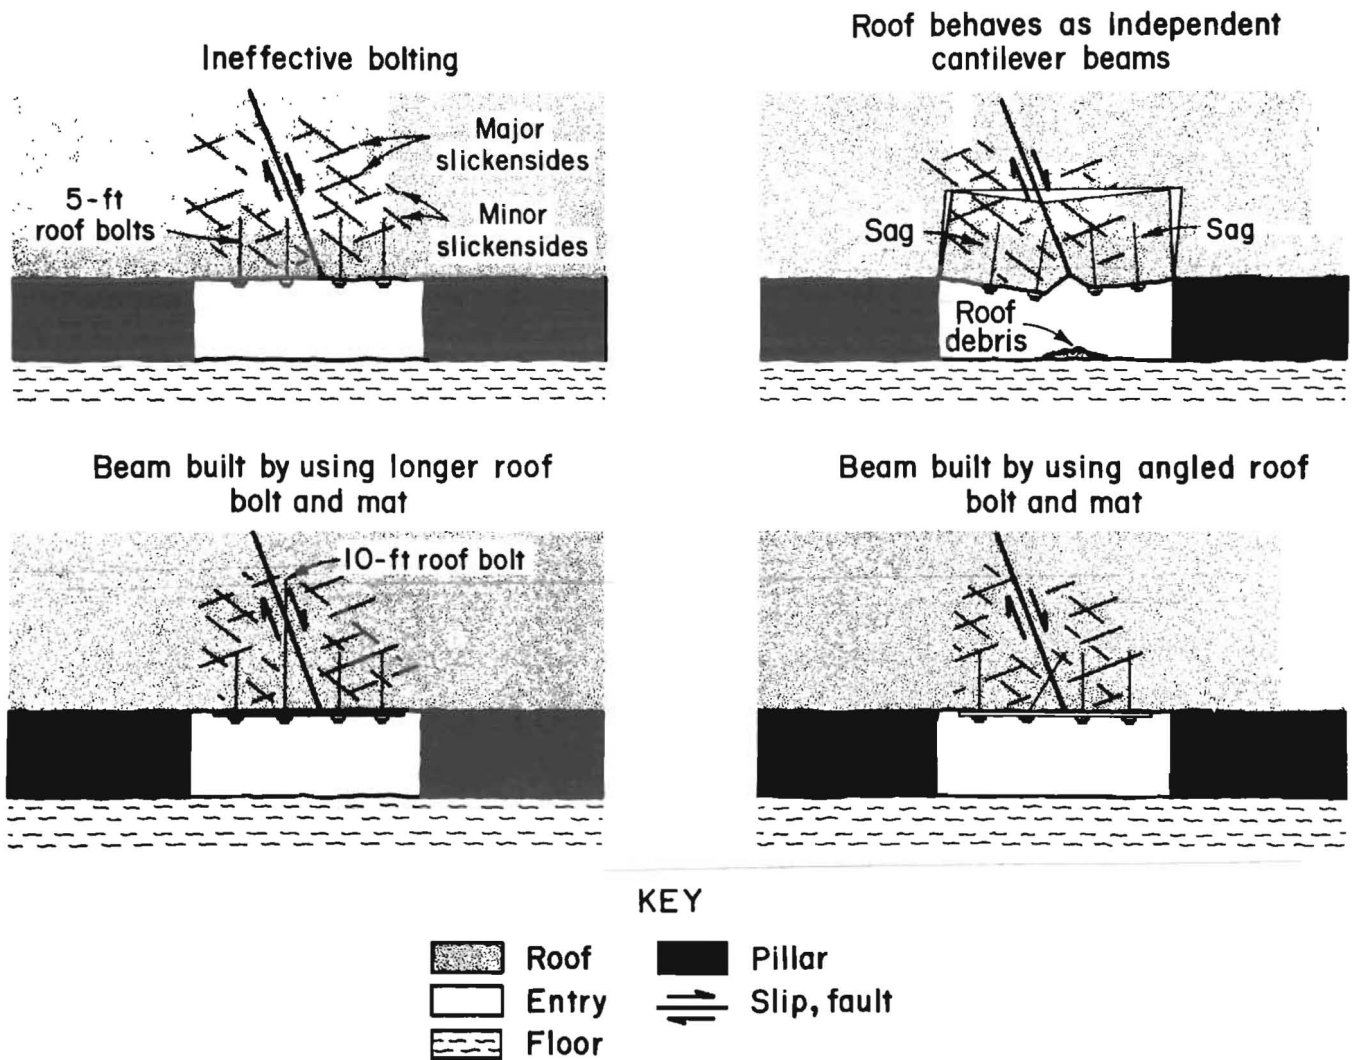
Figure 28.—Supports used in steeply inclined fault plane in roof.
